**Radiological Scanning Update –
Building 3, Site 32 and Selected Sewer
Lines – Field Work Update**

Former Naval Station Treasure Island

May 2014 BCT Meeting
Danielle Janda, Remedial Project Manager

May 21, 2014

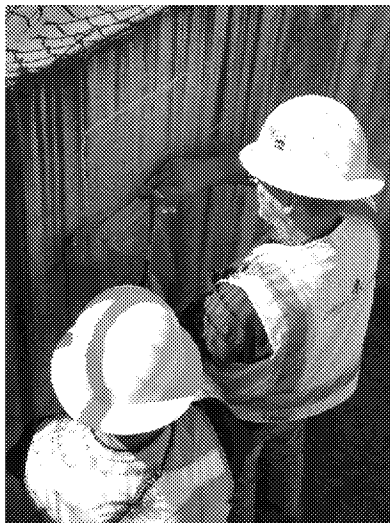
- **Survey of the Holding Tanks is complete**

- Alpha/beta scan and static measurements identified wall areas in both tanks with elevated alpha counts; NO floor areas identified
- Swipe samples identified NO removable radioactivity
- Samples of the wall concrete collected
- Valves cut and samples collected from inside piping
- Awaiting sample analytical results from lab

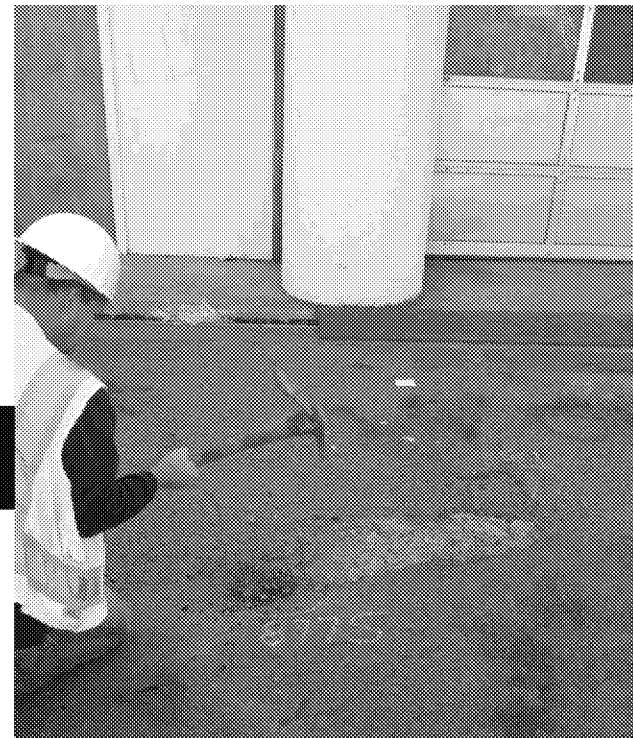
- **Survey of Building 3 is complete**

- Alpha/beta scan/static measurements and swipe samples identified NO evidence of radioactive contamination in building interior
- Gross gamma scan identified small area outside building on southeast side with slightly elevated counts
- Sample collected for analysis
- Awaiting sample analytical results from lab

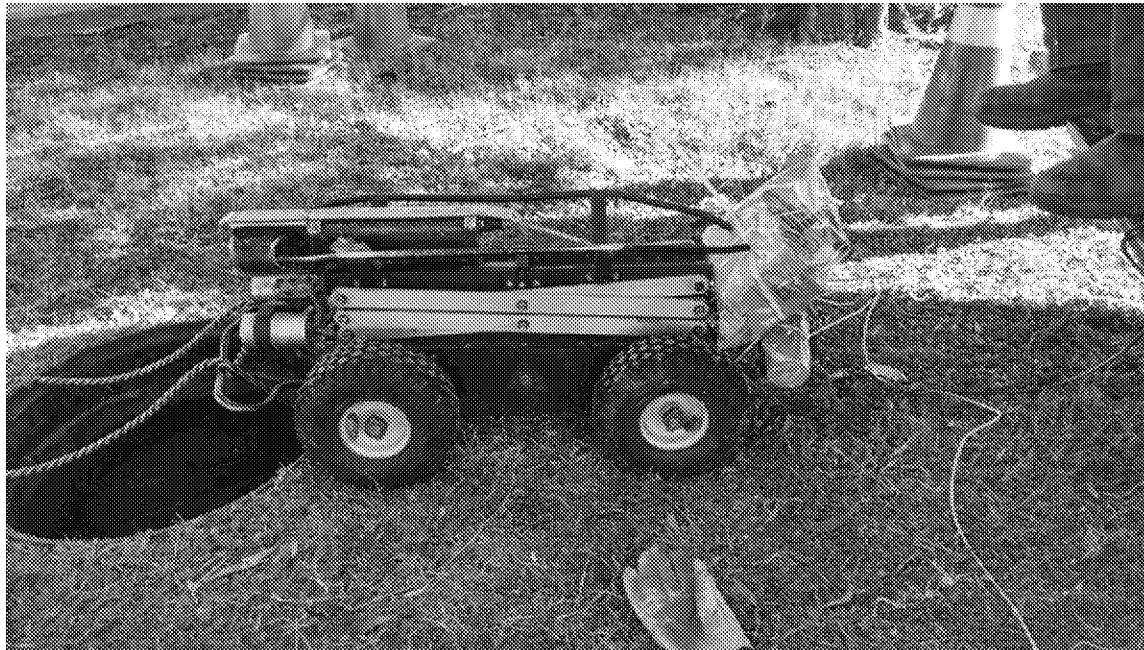
- **Survey of storm drain south of 4th St. along Ave. M is complete**
 - Pipe diameter: 24" to 36"
 - Method of access: manholes (4)
 - Data collected: video, gross gamma readings using 2x2 NaI detector
 - Preliminary finding: NO evidence of radioactive contamination

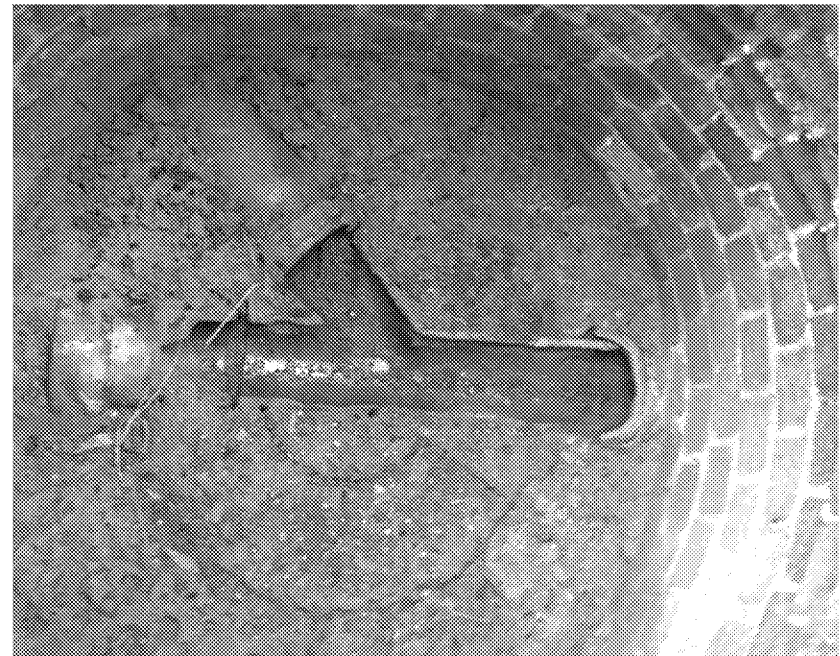
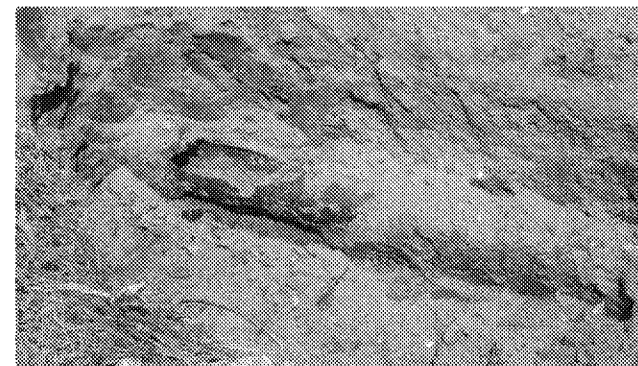
- **Survey of wastewater line downstream of Building 233 is complete**
 - Pipe diameter: 6-8 in
 - Pipe depth: 4-6 ft (restricted surveyor access due to depth)
 - Method of access: manholes (3), potholes (3)
 - Data collected: gross gamma readings using 1x1 NaI detector, samples of material inside pipe, soil samples beneath pipe
 - Awaiting sample analytical results from lab
 - Preliminary finding: NO evidence of radioactive contamination
